2024

ANNAPOLIS ROYAL WHARF

STRUCTURAL ASSESSMENT AND CONDITION REPORT

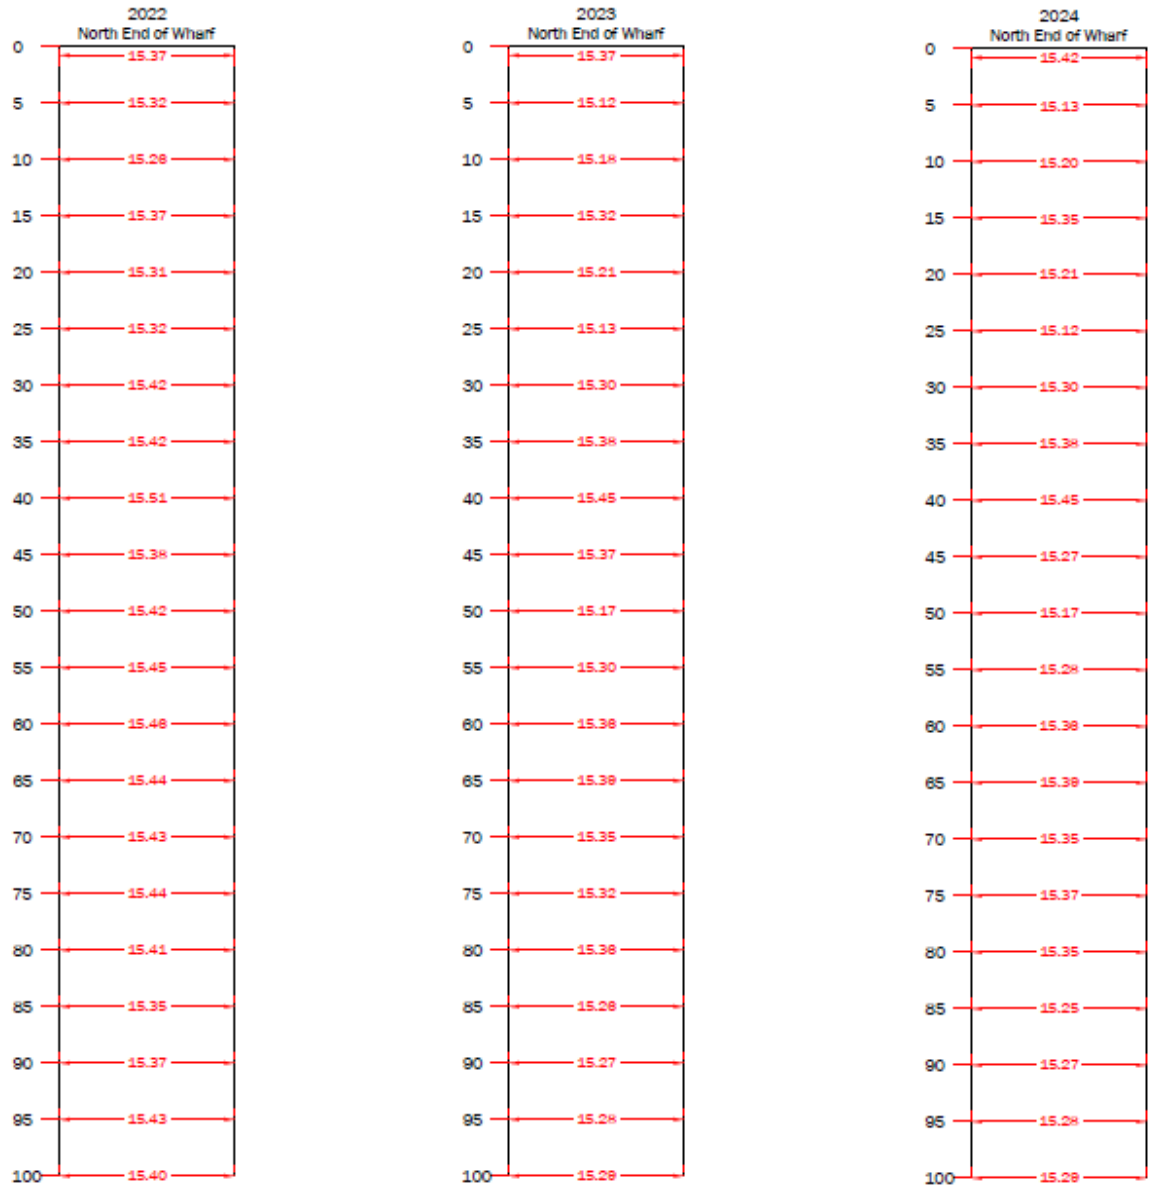
Figure 2 – Annual Wharf Measurements (2022 to 2024, inclusive)

Each year, the top width of the wharf was measured at 5-metre intervals for its full length to document irregularities and to be used for comparison of sheet piling displacement over time. ABLE took its first set of wharf measurements on June 7, 2022, then again in 2023 and 2024. Comparative measurements to the inside edge of the timber curb can be found in Figure 2 on the following page.

When returning to site in June of 2023, it was observed the curb was displaced to facilitate the addition of a new sign. Measurements for 2023 were again taken to the timber curb, see Figure 2, but a second set of measurements to steel angle iron were also taken. Measurements from 2024 have been added to Figure 2 showing measurements from the angle iron have been stable over time.

Readings this year were stable compared to last year with most stations having only a centimeter or two of change. The measurements taken in 2024 indicate the width of the wharf has shown little change in the past year.

- As mentioned previously, measurements of the width of the wharf were taken at 5-metre intervals along the length of the wharf. The results shown within this report show it has been relatively stable over the past year. These measurements should also be checked and compared at a minimum once per year to determine if the sheet piles are moving outward. This will most likely provide a good indication or early warning of failure of the steel tie backs that are not accessible to inspect inside the wharf rock fill.

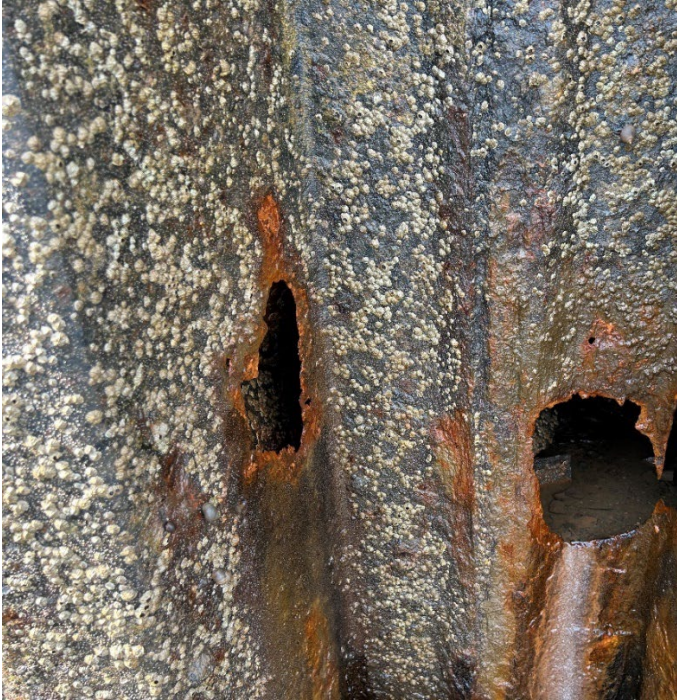
It is exceptionally important to mention the holes on the northeast end of the wharf at the bottom of the piles have continued to expand as the steel continues to rust away. Noting some of these sheet piles have rusted more than halfway off. Complicating this is that they rusted at the bottom of the structure where loads are heaviest. It is, therefore, urgent these are repaired as soon as possible to prolong the useful life of the wharf. Failure to complete this work could result in further damage, seepage of the internal rock material and/or the potential for the end of the wharf to collapse (noting the possibility of all this occurring is heightened during storm events).

Further deterioration and holes left unpatched from the 2023 assessment were also noted during the May 2024 inspection, particularly on the east side of the wharf. There were several large holes completely through the sheet piles which will allow the rock to wash out if not patched.

The sheet pile deterioration was most pronounced on the lower sections of the east side near the north end (see Figures 3 and 4). It was noted that there are six large holes near the bottom of the wharf where the floating ramp sits at low tide.

Figure 3 – Rust Deterioration on Lower East Side of Wharf

Area of rust deterioration at the bottom of the structure should be fixed immediately to avoid further loss of integrity. As mentioned previously, the weight of the structure rests on these piles. Further damage could result in interior rock spilling out and the structure collapsing.

It is recommended immediate repairs be made to patch any holes in the sheet piling with ½” steel plate welded in place to solid steel materials around the hole. This will help prevent the loss of rock and fill from inside the structure which would further weaken it, and to help maintain the structural integrity of the sheet piling.

The northeast end of the wharf on the east side has several rather large holes (6) that need immediate repair near the low tide level. These are accessible at low tide from the floating ramp on that side. These appear to have been missed the last two years when repairs were being made, and these are the sheet piles that when they fail will cause the most damage to the wharf.

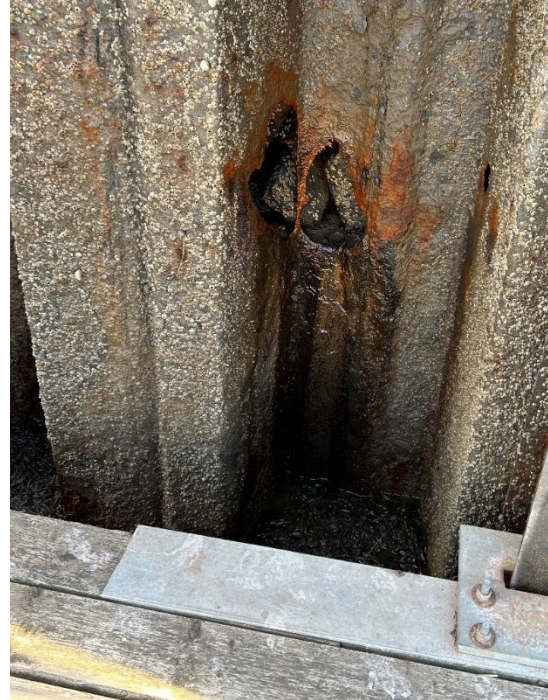
Figure 4 - Sheet Pile Deterioration at Drainage System Level, East Side of Wharf Near North End

- Continue patching holes as they appear in the sheet piling to stop the loss of rock from inside the wharf structure. **Note: do not weld patches completely over the drain holes near the bottom of the sheet piling as these are needed to allow water pressure to equalize or be minimized from rising and falling tides.** Repairs of further wharf elements are recommended as follows:

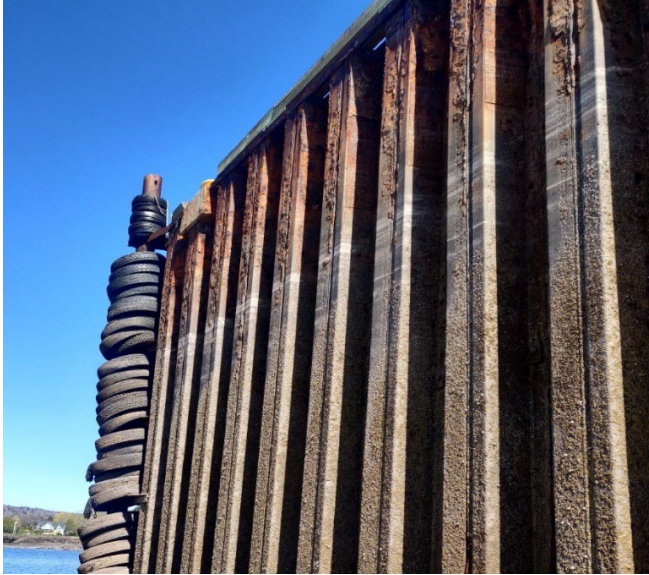
During the 2024 inspection, it was noted the patches that were completed previously have held up well, most of which were completed on the west side of the wharf near the top (see Figure 5, 6 and 7). These patches appear to remain in good condition and blend in with the rest of the wharf.

Figure 5 – Three Patches Near the High Water Mark on West Side of the Wharf in Good Condition

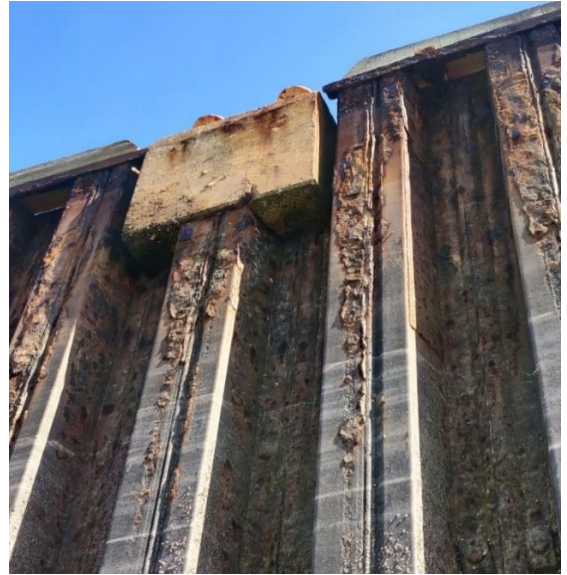
Figure 6 – Patch on West Side of Wharf Near Top in Good Condition

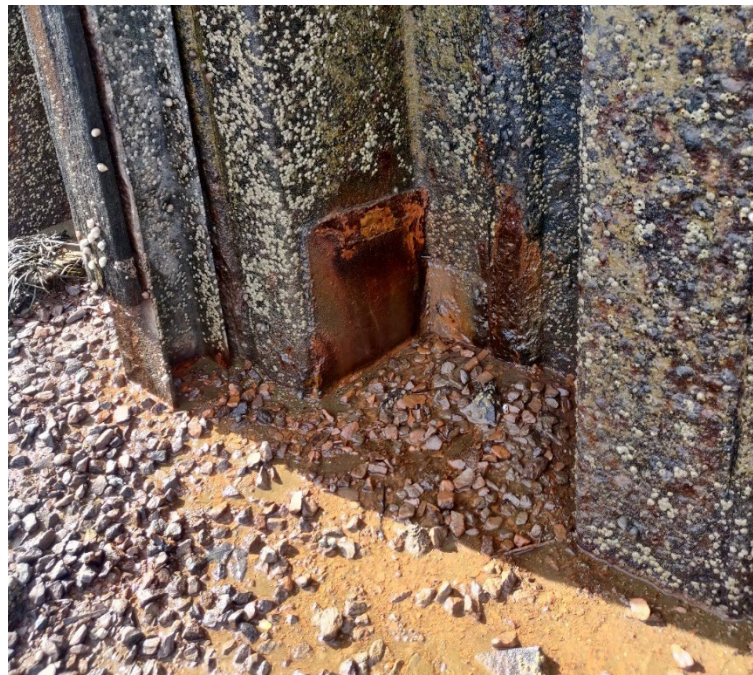
Figure 7 – Patch on East Side of Wharf Near the Bottom

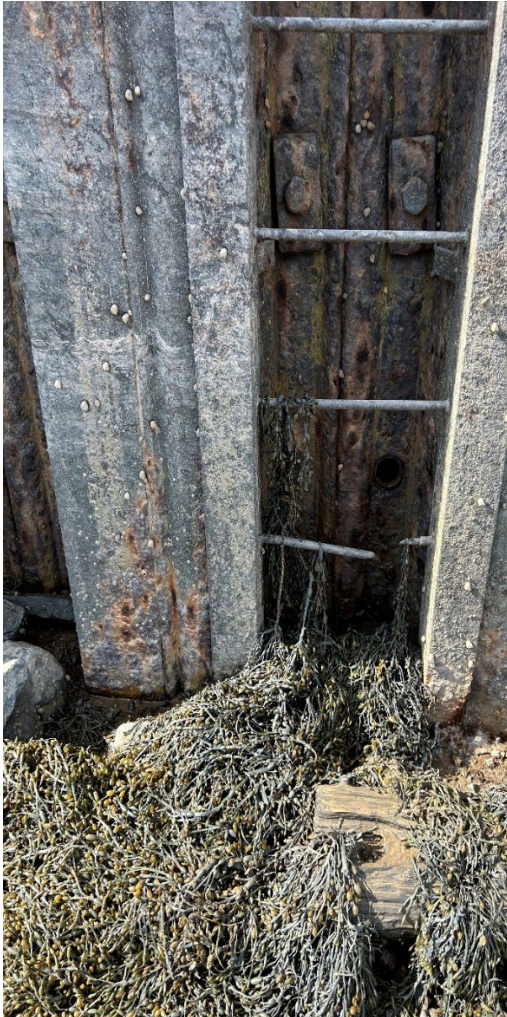
During the 2024 inspection, it was noted the existing ladders still require attention. Figure 8 shows the rungs having completely rusted off. It was also noted a new aluminum ladder was installed at the wharf (Figure 9). This ladder is portable and can be moved from one area to another depending on the requirements. If the existing ladders are not to be fixed, and their use

Figure 8 - Example of Damaged/Broken Ladder

discontinued, they should be removed, or proper signage should be installed noting their failed condition.

- Repair ladders up the side of the wharf.
- Patch holes in asphalt where weeds are growing.
- Regular inspections are still recommended.
 - In addition, it is recommended that town staff assess the structure to identify any of the above changes monthly and after any major storm. Should damage, movement or settling of the structure be detected they should request the services of a professional engineer for inspection as soon as possible. The Town may wish to consider a twice-annual inspection as the end of the useful life of the wharf approaches.

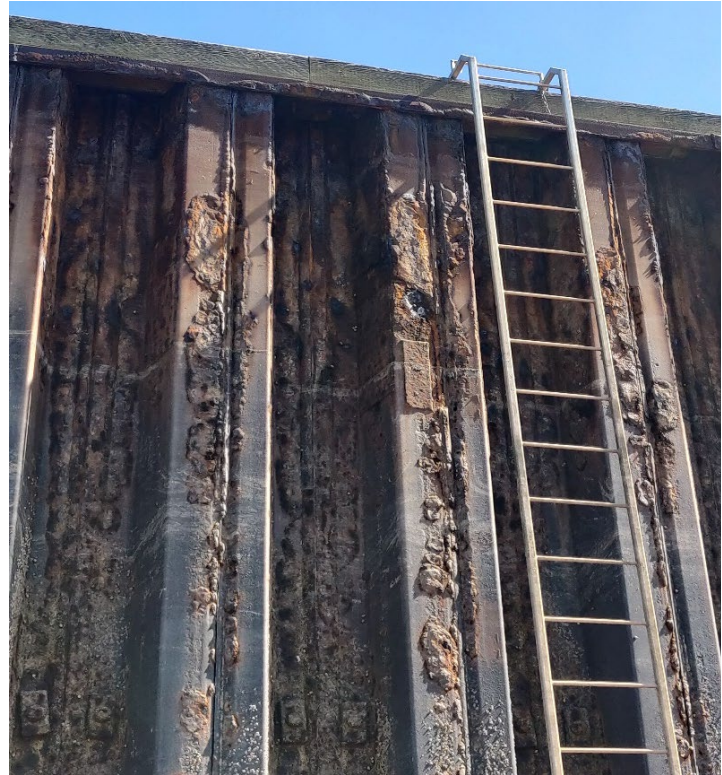
Figure 9 - New Portable Aluminum Ladder Installed in 2023

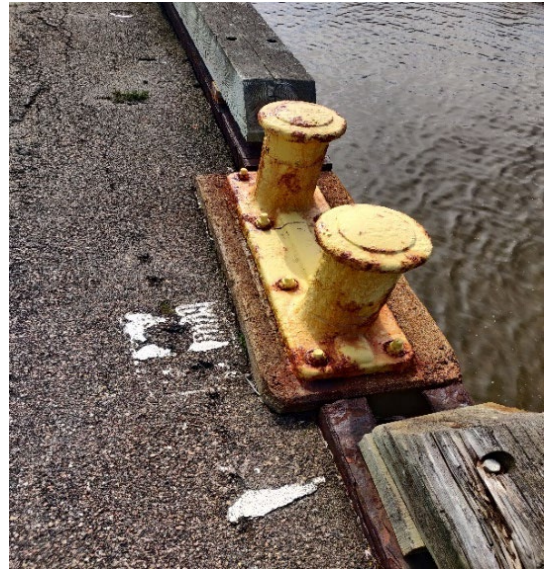
The steel bollards themselves appear to be in good condition; however, they are supported on top of rusting and deteriorating sheet piling. This infers they are only going to hold as much as the sheet piling beneath them can support the lateral loads. The bollards can be seen in Figure 10.

Figure 10 - Steel Bollards Anchored in Concrete

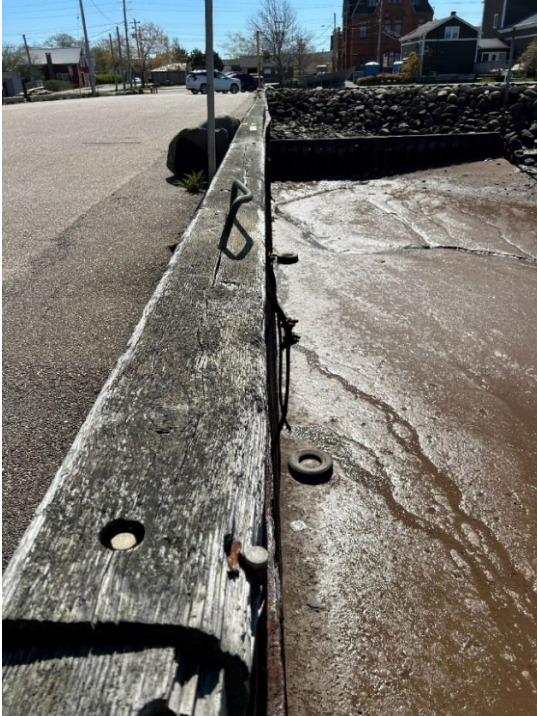
The tire fenders that used to hang on the sides of the wharf to prevent vessels from damaging the wharf (and themselves) have all rusted off. The steel cables holding them in place rusted away, and the tires have fallen to the bottom of the wharf (Figure 11). No tire fenders remain on the wharf.

Figure 11 - Timber Curb with Fallen Tires

With all the tire fenders except the bumpers on the outer corners, and some of the wooden fenders missing, the wharf is less attractive for recreational boaters due to the damage that could be caused to their boats. Without the cushioning of the tire fenders, damage can and will likely occur to both boats and the wharf itself.

- Replace tire fenders and wooden fenders along the sides of the wharf that have fallen off at least on the east side as this is the side which is most often utilized as the prevailing winds are from the west.

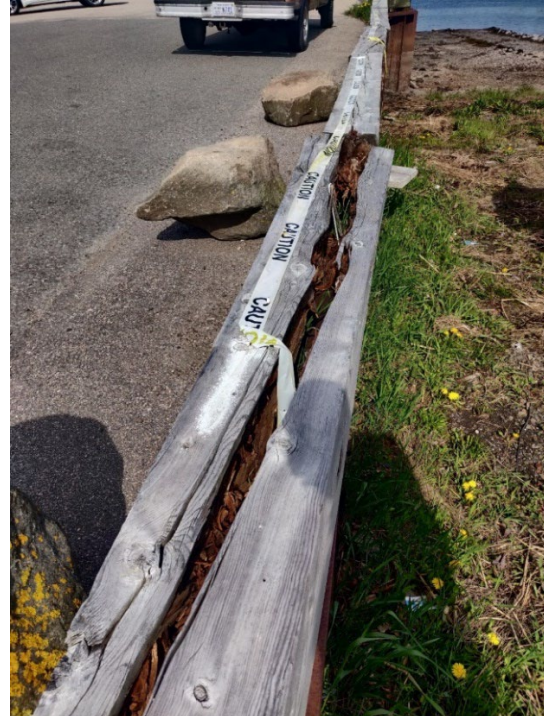
The wharf's surface has an 8" x 8" timber curb running along the perimeter. The condition of the curbs has deteriorated and are considered of poor condition. Some of the timbers were seen to be rotting (Figure 12) with a notable difference in the timber on the east side of the wharf compared to the west (in better condition).

Figure 12 - Timber Curbs on East Side of Wharf Rotten

The steel that the timbers are fastened to is deteriorating. Large rocks and caution tape have been placed on the east side of the wharf warning of the timbers that have deteriorated to the point that they would no longer stop a vehicle from going over the side. Therefore, the rocks have been placed along the edge to keep vehicles back.

- Replace timbers around top of deck, where needed.
 - This can be done with locally obtained rough sawn timbers. Hemlock and cedar are good for this purpose, and it does not need preservatives added to protect.

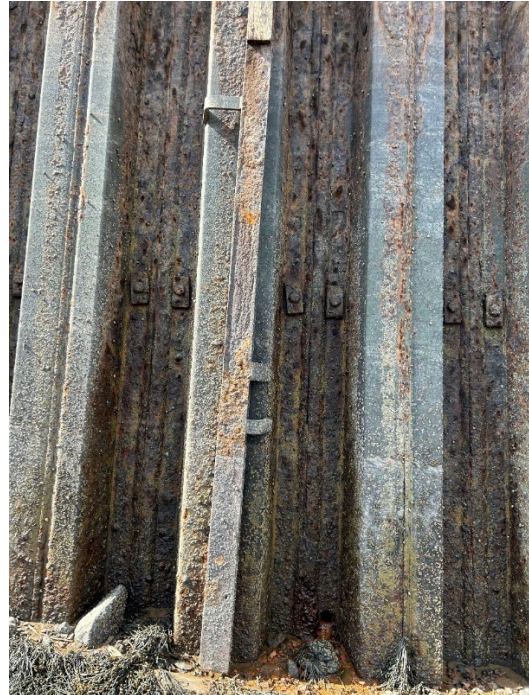
Figure 13 - Wooden Fenders on Side of Wharf Missing

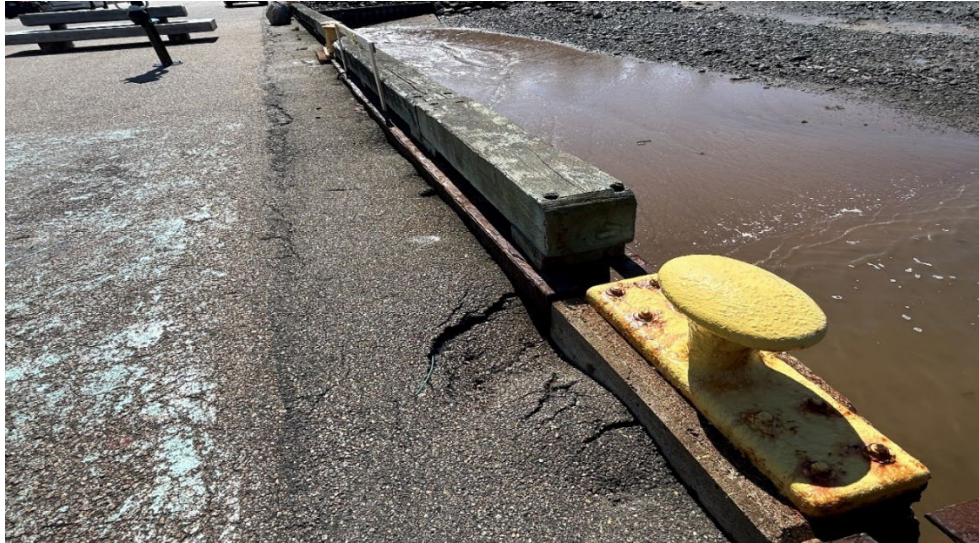
The asphalt deck is still in fair condition but has some signs of settlement and longitudinal cracking 12 to 24” from the side of the wharf.

In addition, some grasses and vegetation are starting to grow in the cracks in the asphalt. There does not appear to have been any substantial loss of materials from inside the rusting piles and the depressions that exist along the sides do not appear to be any worse when compared to 2022.

Figure 15 –Settling Along Sides of Asphalt Deck

The asphalt should be observed closely and inspected frequently for any signs of further settlement. An example of asphalt settling along the sides of the wharf can be seen in Figure 15. The Town may consider signage to caution wharf users of the uneven asphalt to mitigate safety concerns.

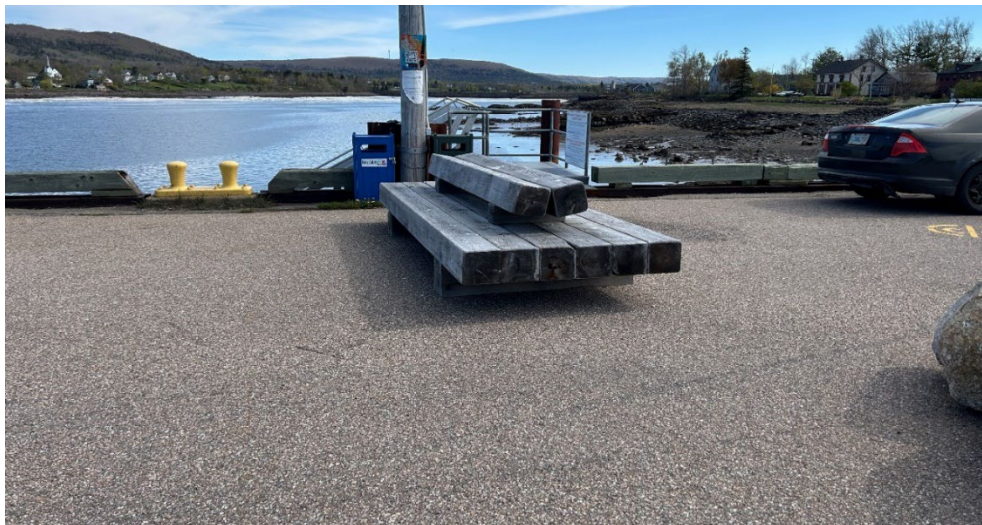
New park benches have been installed on the north end of the wharf. These also act as traffic barriers to keep vehicle traffic from driving out to the end of the wharf. In addition, a telescope was installed in this area to allow users to view the water and marine life along the Basin.

Figure 16 - New Bench Seats

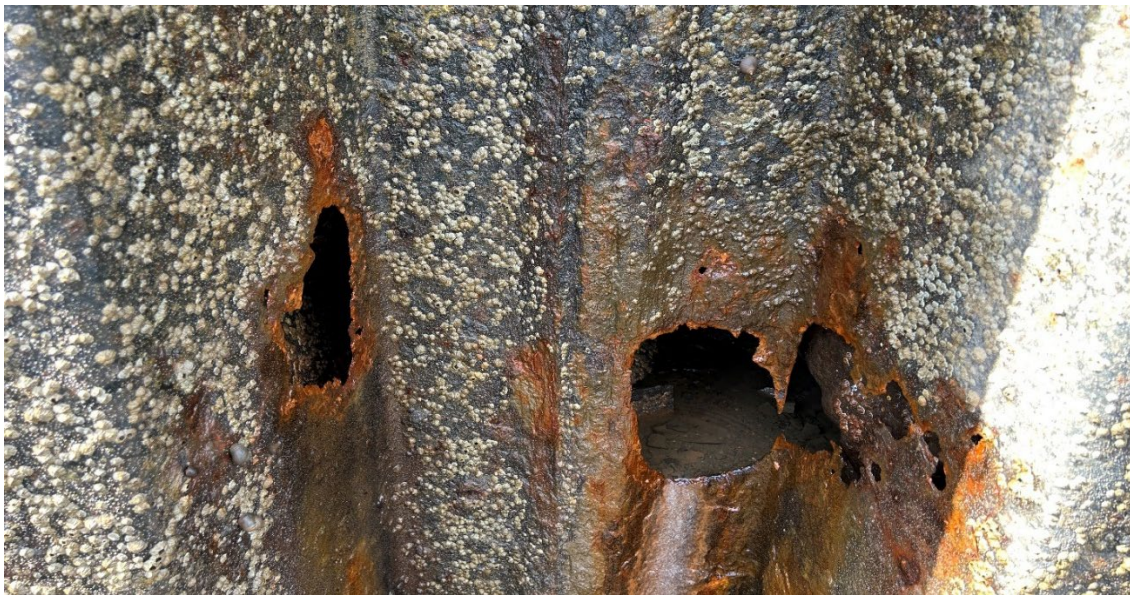
Sheet Pile on Lower East Side Nearly Rusted Through (requires urgent patch).

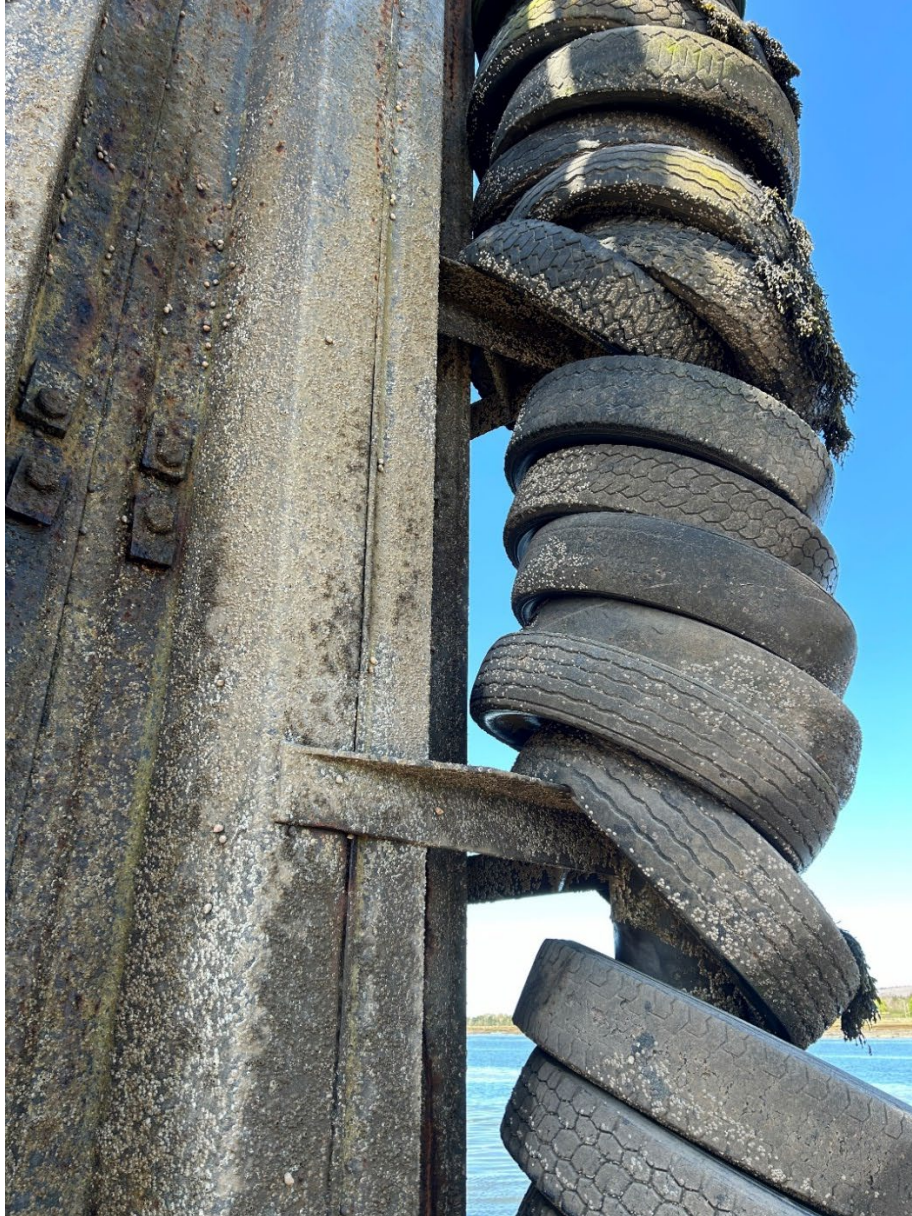
Tire Corner Fenders on North End of Wharf Still Intact

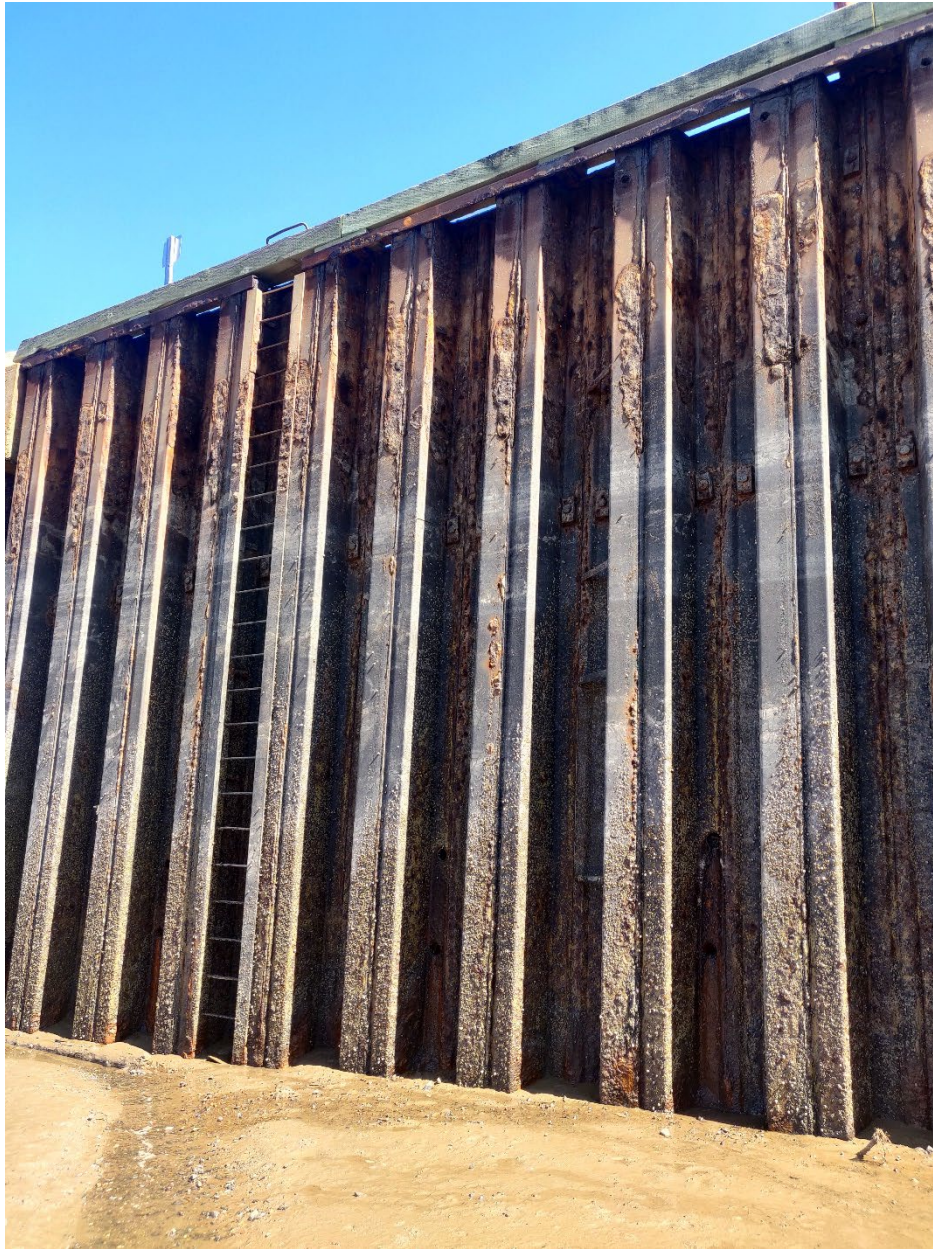
West Side of Wharf Showing Drainage Holes Near Bottom of Piling
